OSA -1293-67

20 March 1967

Subject: OXYGEN RESTRICTION IN AIRPLANE 130

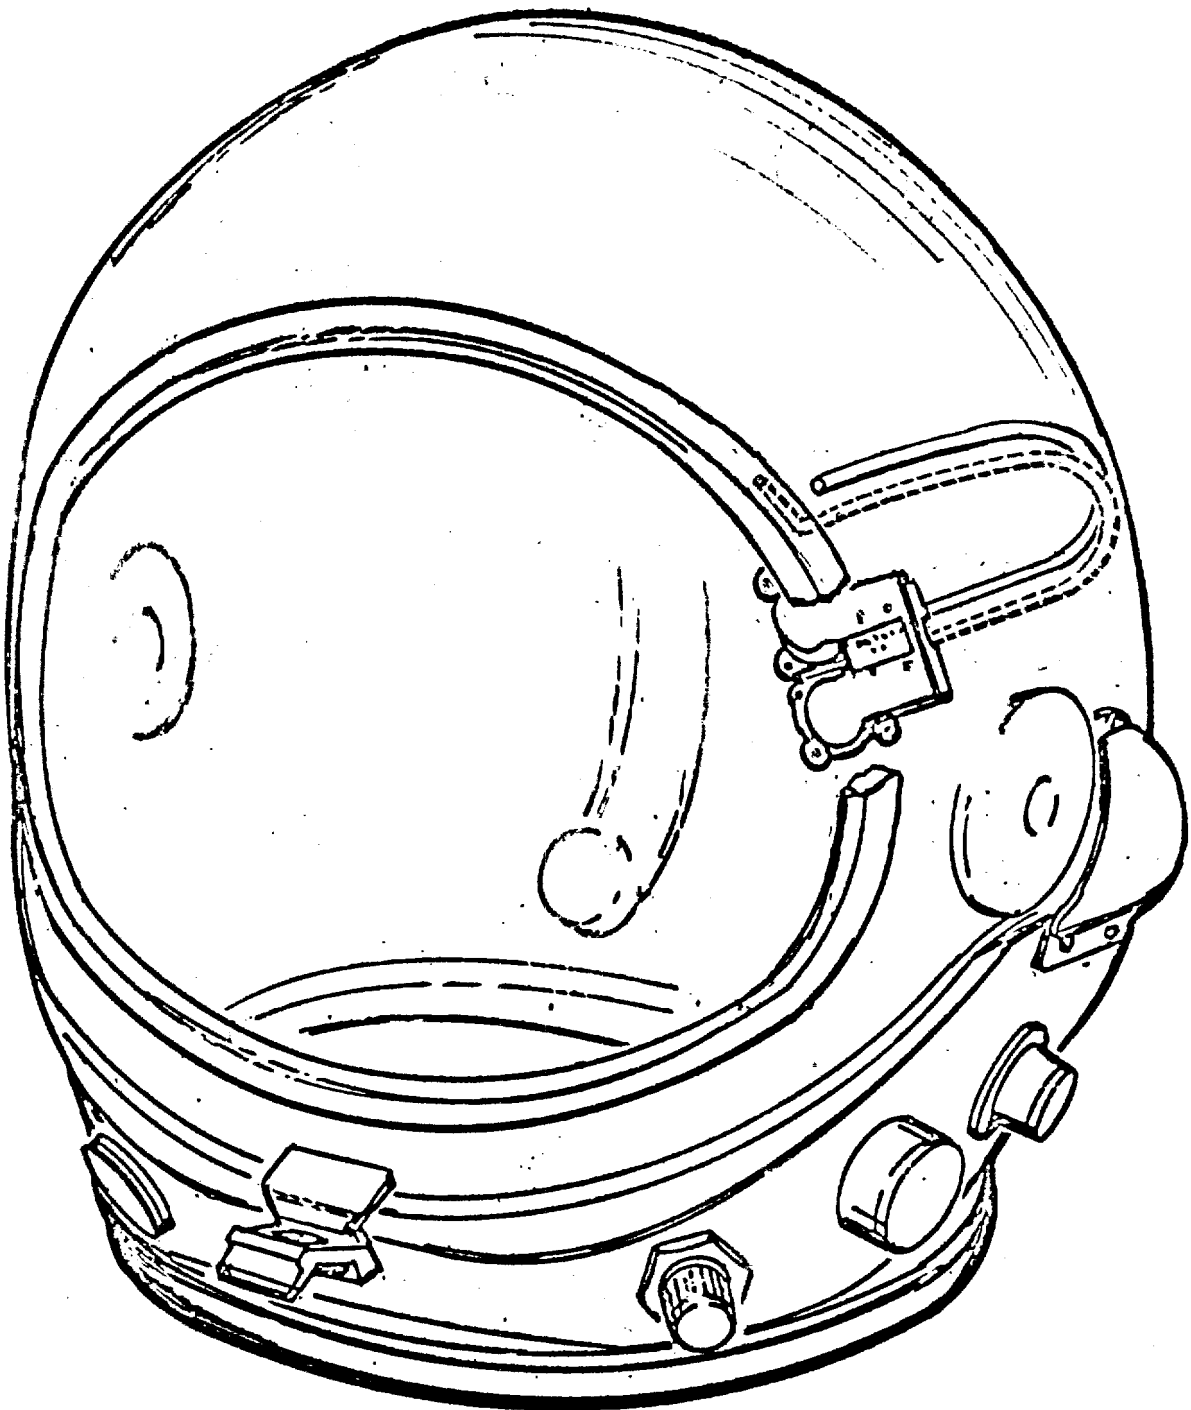
SINGLE OXYGEN DEMAND AND SENSE LINES

We are also experiencing another kind of trouble with these pressure reference sense lines at Beale in that entrapped condensate or sweat is permitted to run down into the regulators. The attached sketch shows this present installation - note that the line is downhill so that any moisture or foreign object would go down the tube into both of the regulators.

PRESENT SINGLE .38 OR .19 DIA.

SENSE LINE; PERMITS MOISTURE
TO ENTER REGULATOR
